Ō2NL Council known HAIL sites

Appendix D Ō2NL HAIL site assessment

Appendix E Council Records on known HAIL sites next to the Project designation

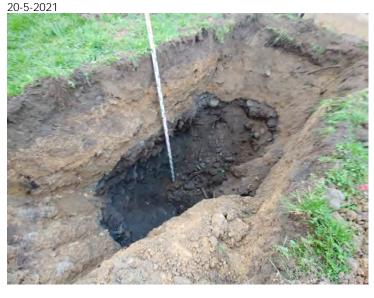
TP235 - Ohau Quarry

TP encountered household refuse (mattresses, pipes, fabric) along with green waste (stumps, cut branches) from ~1m to ~2m. Refuse was covered in gravelly clay FILL.

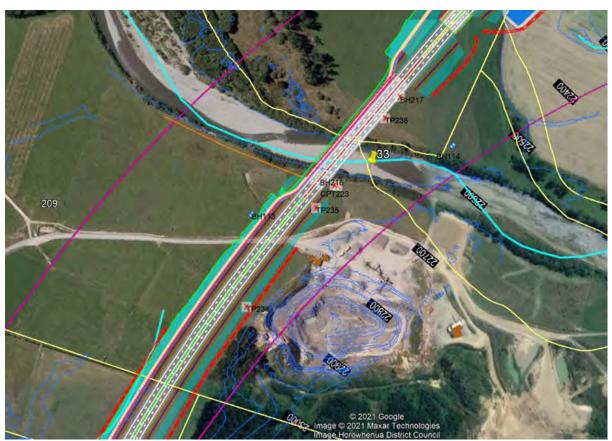
Figure 1-1 Depiction of where the draft alignment for the project intercepts with the potential historical landfill suspected near the south bank of the Ōhau River

As of March 2021, Waka Kotahi NZ Transport Agency (Waka Kotahi) has selected a refined draft alignment for the project (Figure 1-1). On behalf of Waka Kotahi, Stantec is progressing with engineering designs and optioneering, including understanding environmental and social effects, and how these can be avoided, minimised or mitigated. As part of this, ground investigations have been undertaken and these investigations, prompted by anecdotal evidence, have identified an area of land that will be developed within the proposed road corridor alignment as potentially having been used as a landfill. This site is located at 559 State Highway 1, Ōhau (Figure 1-2), on the south bank of the Ōhau River.

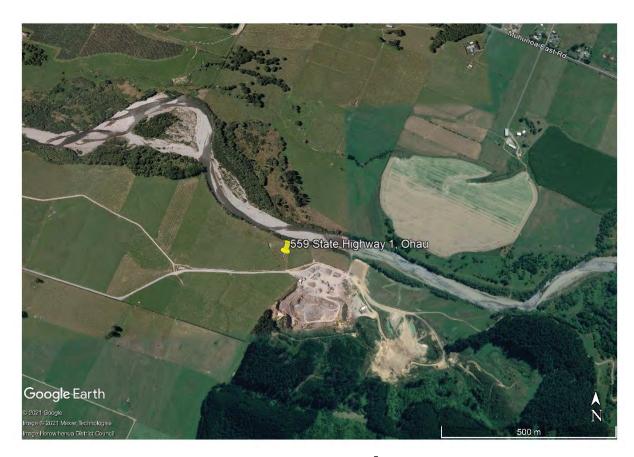
Figure 1-2 Location of sampling sites on the south bank of the Ōhau River

The site of this investigation is located approximately 8km south of Levin and is situated immediately adjacent to Webb's quarry on farmland, as shown in the view above. The Ōhau River is to the north of the sample sites, with the individual sites being between 10 m and 100 m away from the river. There were five sampling locations, as seen in Figure 1-3. These sample locations reflect the form of the Ō2NL proposed bridge approach on the south side of the Ōhau River.

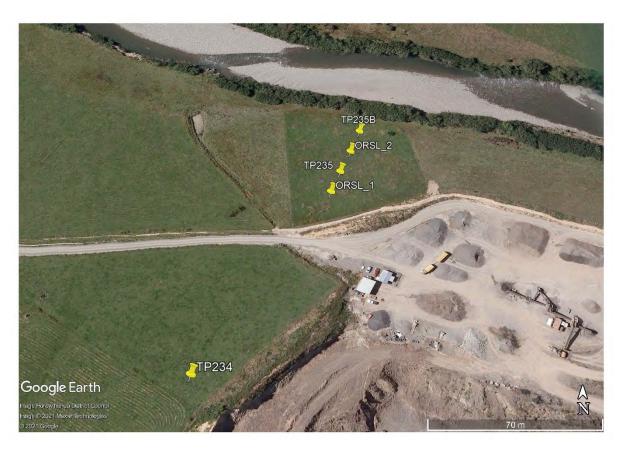
Figure 1-3 Locations of individual samples
